PRELIMINARY SURVEY REPORT:

Plating Shop  
Braniff Airways  
Love Field  
Dallas, Texas

DATE OF SURVEY:  
June 29, 1981

REPORT NO.:  
ECTB 106-16a

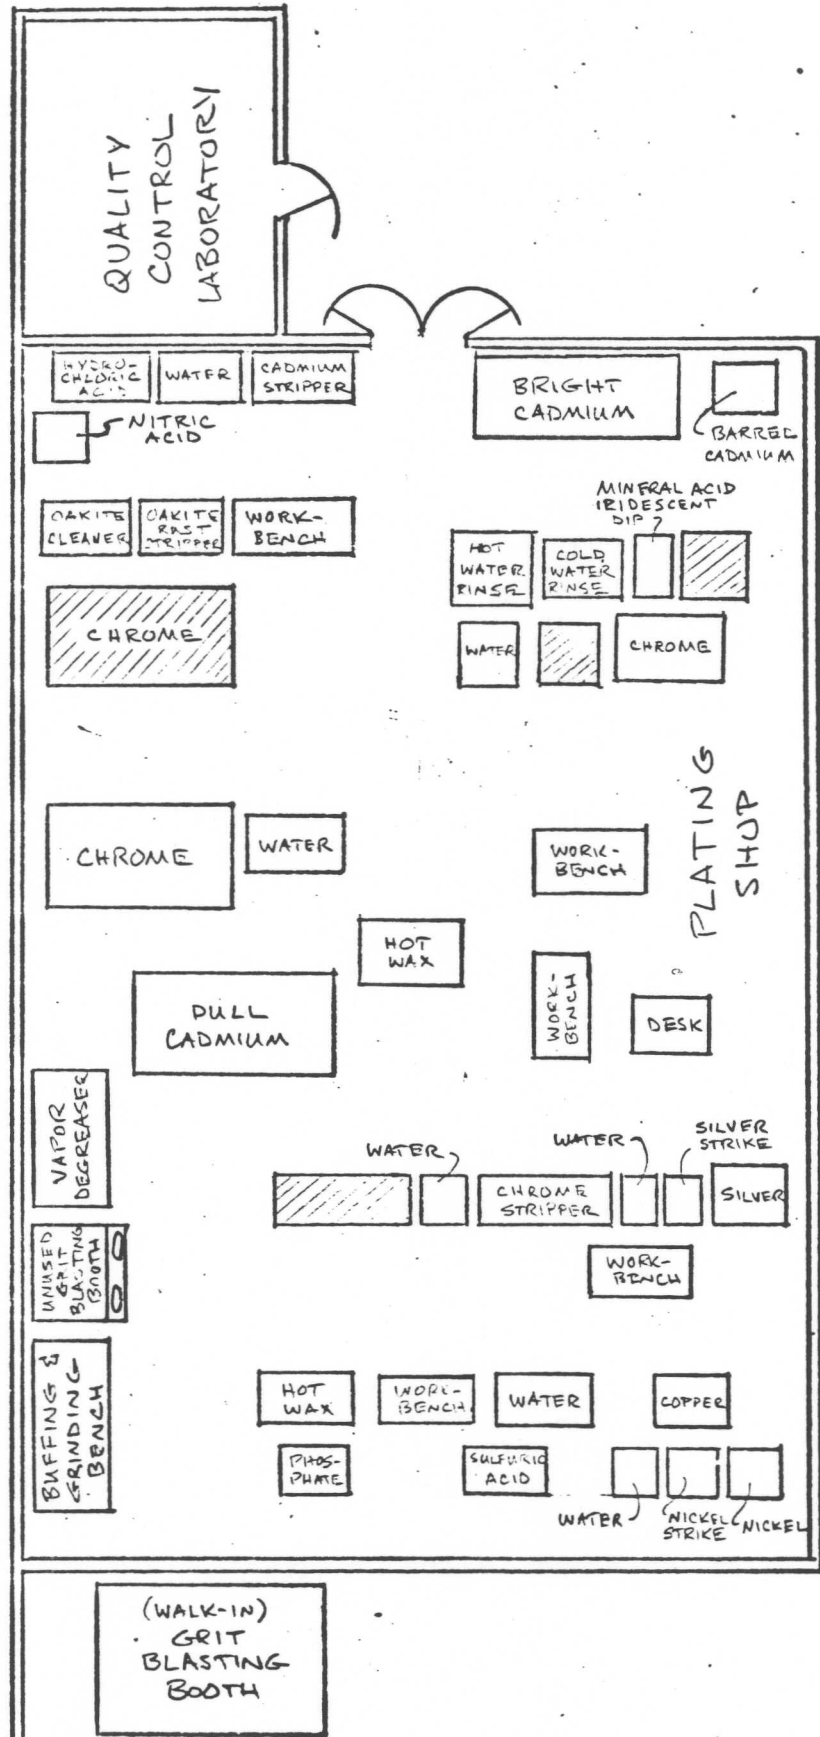
Figure 1. Plating Shop Layout

The layout of the plating shop area is diagrammed in Figure 1. The plating shop is a separate room within the building, approximately 4000 square feet in area with a 20 foot ceiling height. The grit blasting booth is located on the other side of the west wall of the plating shop. A small laboratory for analyzing plating bath concentrations is located adjacent to the entrance to the shop. The area on the other side of the north wall is a bay for stripping and painting airplanes.

The shop is nicely painted and well-maintained. The concrete floors are covered with wood-slatted platforms around the tanks. Local exhaust ventilation is installed on the hard chrome tanks and some of the pretreatment tanks. Two main branches of duct work lead from the plating shop. The exhaust from the grit blasting booth joins the longer outside duct just before its junction with the other duct.
