EG&G ROCKY FLATS

**F.4 Records and Information are Inadequate for Individual Dose:
Technical Reports from Government Entities or Journals**

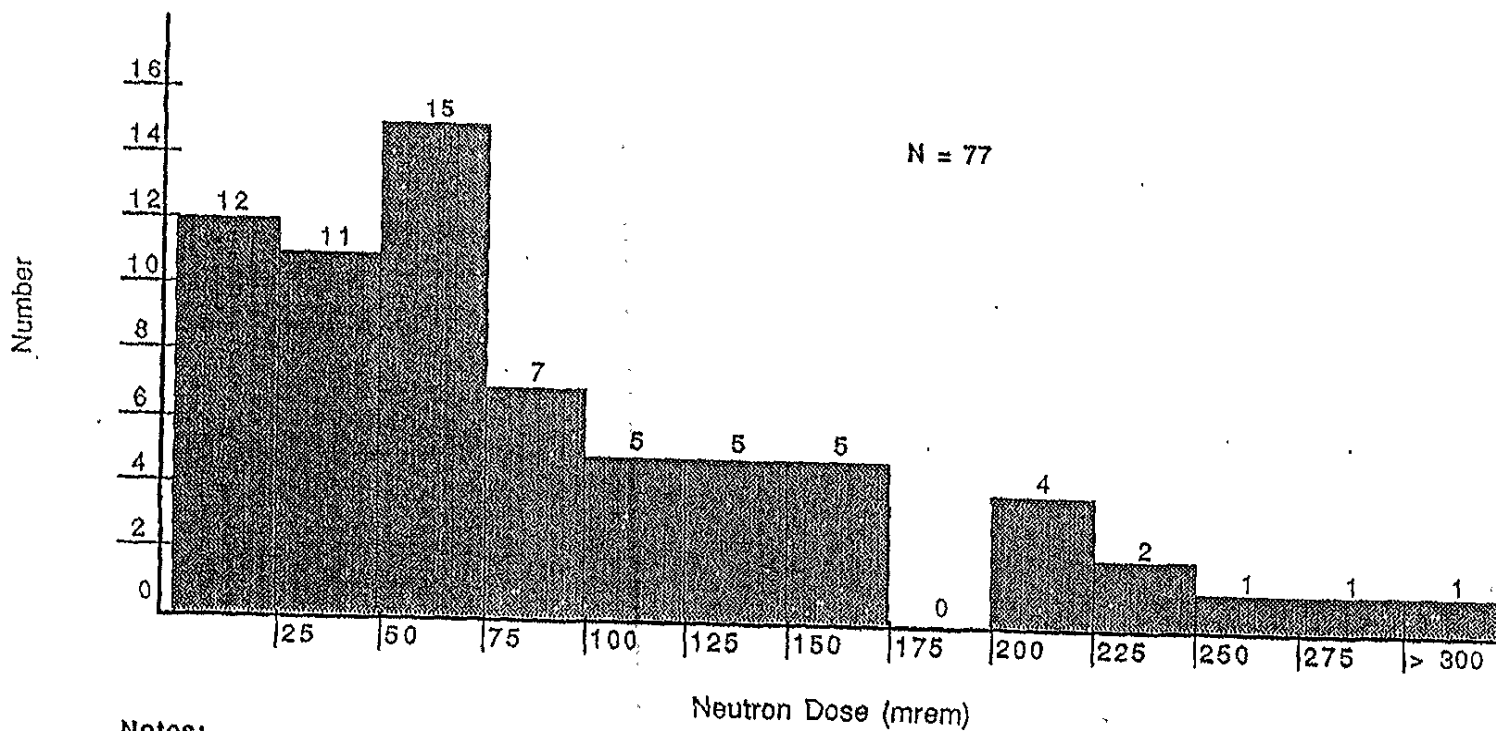
Year 1959. Reevaluated Neutron Doses for Which
Initial Evaluation Was Zero, 2-week Period

1. Highest Neutron Dose = 466 mrem
2. 31% > 100 mrem
3. 12% > 200 mrem

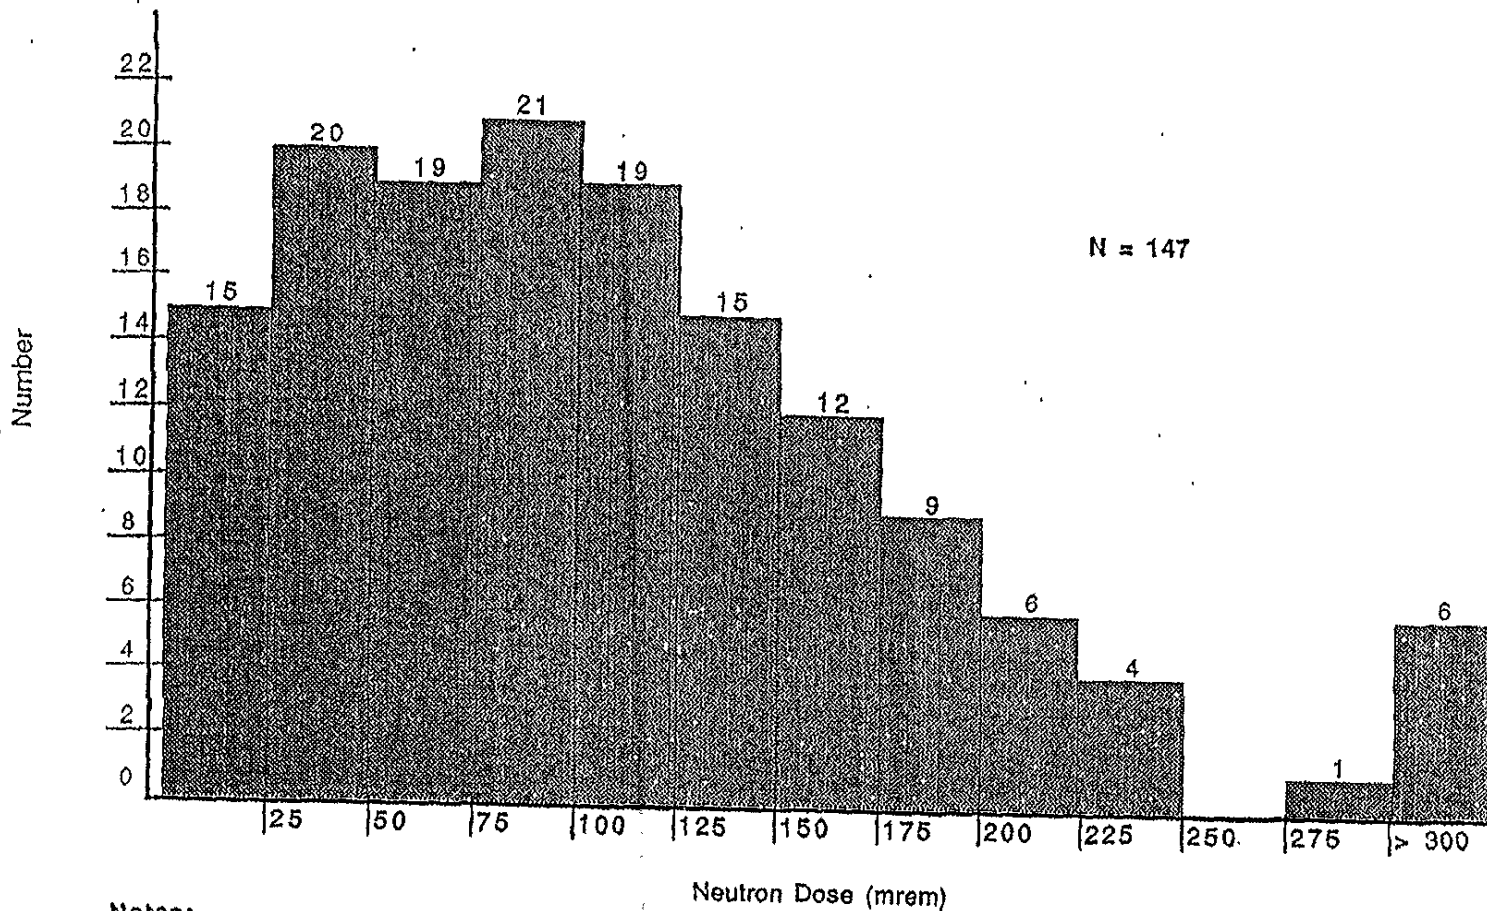
Year 1961. Reevaluated Neutron Doses for Which
Initial Evaluation Was Zero, 2-week Period

1. Highest Neutron Dose = 1,085 mrem
2. 49% > 100 mrem
3. 12% > 200 mrem
